Manhole Inspection Summary

Manhole # S23CC1017MH

Insp Date: 1/30/07 12:32 PM

Location Address: **1434 DELLWOOD AVE**

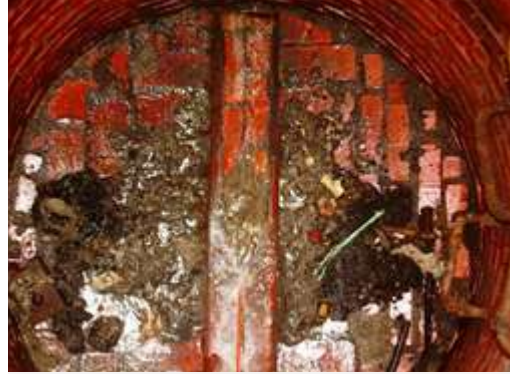
Top View

Corroded steps. Evidence of surcharge - Bench debris. Channel debris.

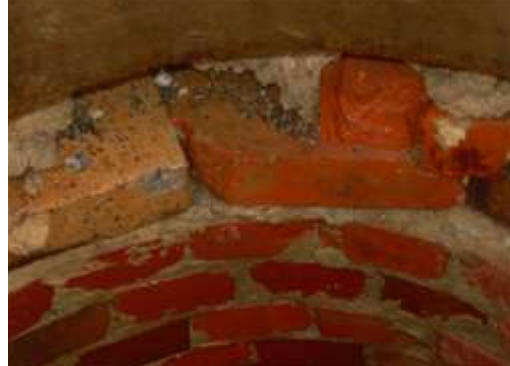
Defect

Frame leaks. Frame offset. Adjustment deterioration and infiltration.

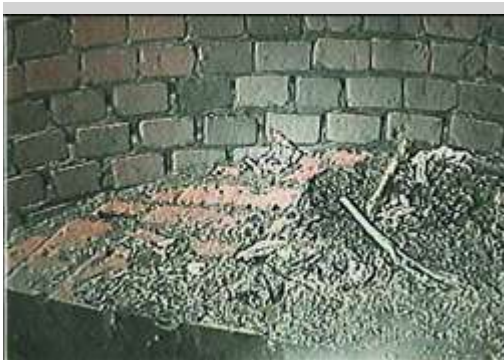
Defect

Barrel deterioration and infiltration. Bench debris.

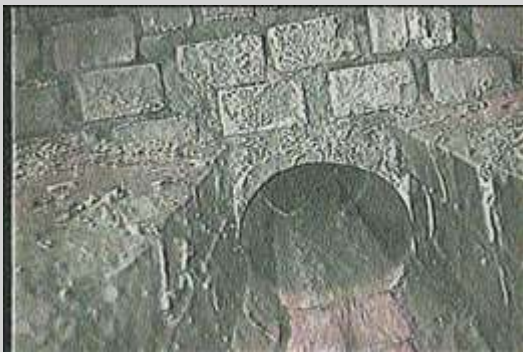
8 in. Circular Gravity Sewer Pipe Out @ 12 O'Clock

Invert Depth: **10.36** (ft.) Flow Characteristics: **Slow**

Deposits: ☒ None ☐ Mud ☐ Sludge ☐ **Debris** ☐ Grease

Infiltration: **None** Pipe Seal Cond: **Unknown**

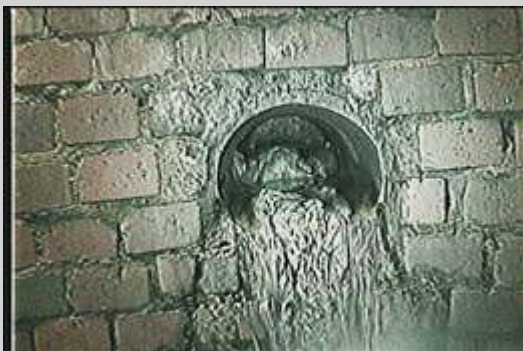
8 in. Circular Gravity Sewer Pipe In @ 6 O'Clock

Invert Depth: **8.29** (ft.) Flow Characteristics: **Slow**

Deposits: ☐ None ☐ Mud ☐ Sludge ☒ **Debris** ☐ Grease

Silt Depth: **0** (in.) Deposits Extent: **Medium**

Infiltration: **Evidence** Pipe Seal Cond: **Unknown**

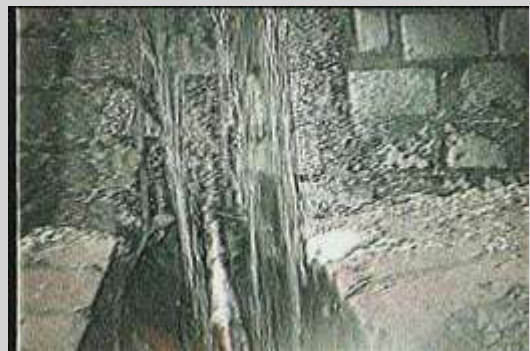
Drop In @ 6 O'Clock

Drop: **Outside** Rod and Bar

Angled: **Yes** Reading: **9.10** (ft.)

Inv Depth: **10.10** (ft.)

Drop Condition: **Clogged**
